AIRCRAFT ACCIDENT REPORT 1/2020

Report on the accident to
Piper PA-46-310P Malibu, N264DB
22 nm north-north-west of Guernsey
on 21 January 2019

Air Accidents Investigation Branch

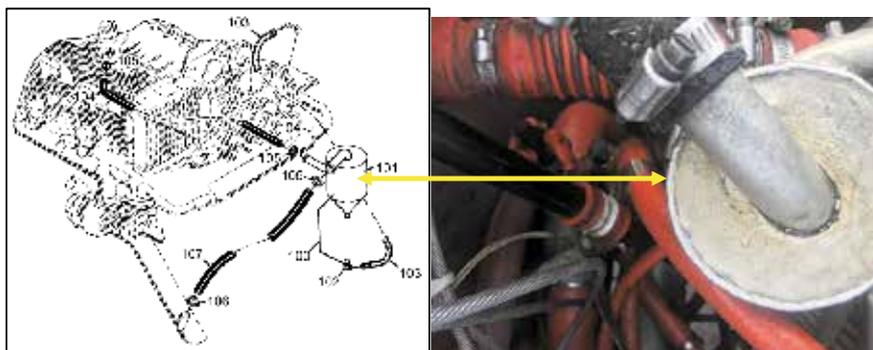
Figure 10

Following the engine ground run carried out at Nantes to investigate the bang on the outbound flight, the pilot noticed what he thought might be a small oil leak from the top of the oil accumulator, which he believed had been present for some time. The pilot took photographs, which he sent to the individual who managed the aircraft who then forwarded them to the FAA IA. From one of the photographs, the component was identified by the engine manufacturer as the air / oil separator assembly (Figure 10).

Photograph sent by pilot showing location of oil leak from the air / oil separator (item 101 in the left image)

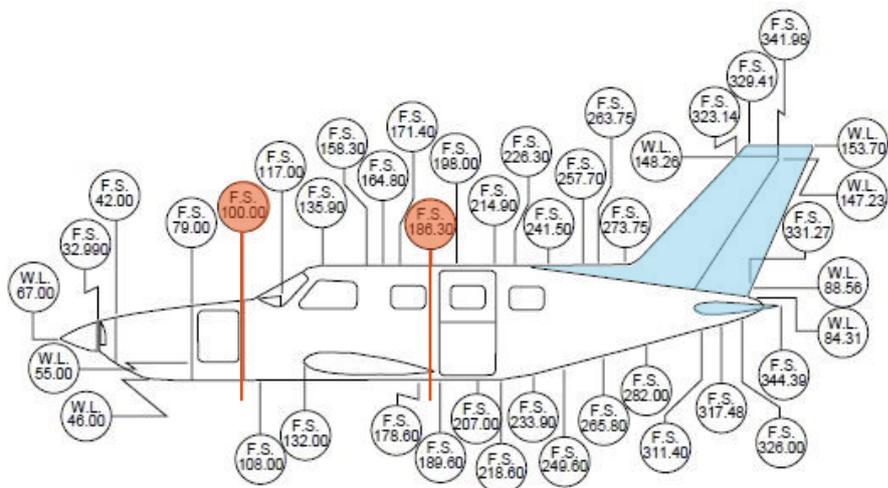
Figure 13
PA-46 fuselage

The central fuselage had broken away from the nose section at Fuselage Station (F.S.)100 and from the tail section at F.S. 186.30 (shown in orange in Figure 13). The roof section of the central fuselage aft of the front seats was missing. There was significant compression damage along the top of the aircraft from the windscreens to the tail cone. There was no evidence of compression damage on the lower surface of the tail section. The fin and horizontal stabiliser assemblies had detached from the tail section at their attachment points (shaded blue).

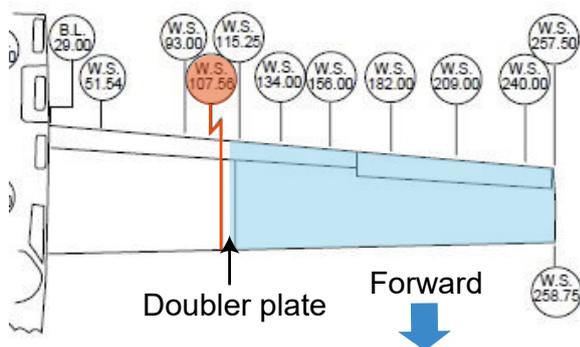
Figure 14
PA-46 left wing

The left wing and flap had failed at Wing Station (W.S.) 107.56 (shown in orange in Figure 14) beneath the skin doubler plate where the inboard section of the wing joins the outer section (shaded blue) at the splice joint. The inboard section of the main wing spar appeared to be undamaged. The failure of the main spar splice joint and the adjacent structure was consistent with the wing failing due to a downward bending force. The top wing surface displayed evidence of a compressive force that had pushed the skins inwards with the edges having been torn away from the fasteners. The remainder of the wing structure and flaps were extensively damaged.

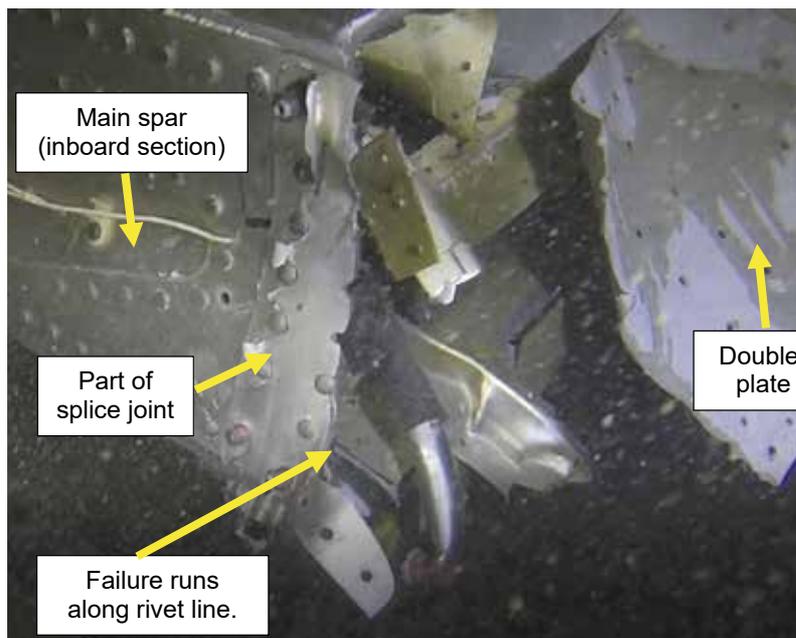
Figure 16

Failure of left-wing main spar at the splice joint
(Image taken from a video provided by Blue Water Recoveries)

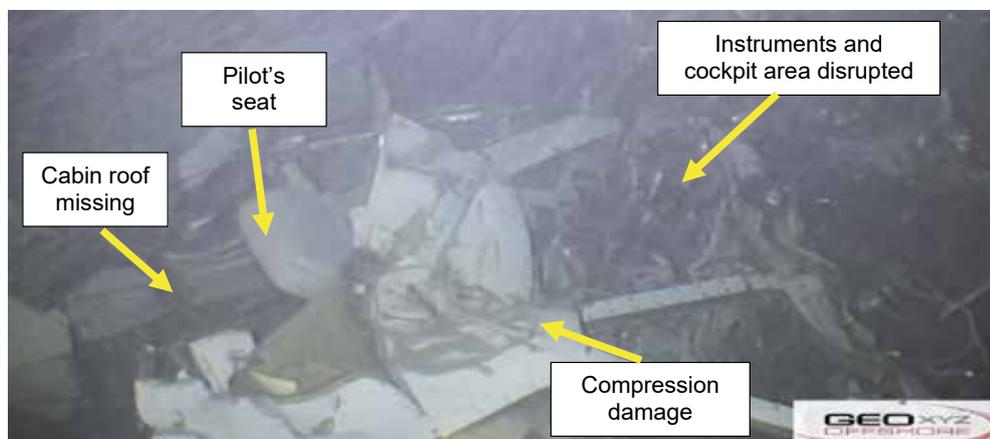
Figure 17

The cockpit and cabin area had been severely disrupted. The pilot's seat was intact, though the harness was missing. The harness for the right front seat was still in place and had been secured in a manner suggesting that this seat had not been occupied during the flight. Figures 15 to 20 show some of the damage described in this section. Further images of the wreckage are in Appendix B.

Damage to cockpit roof

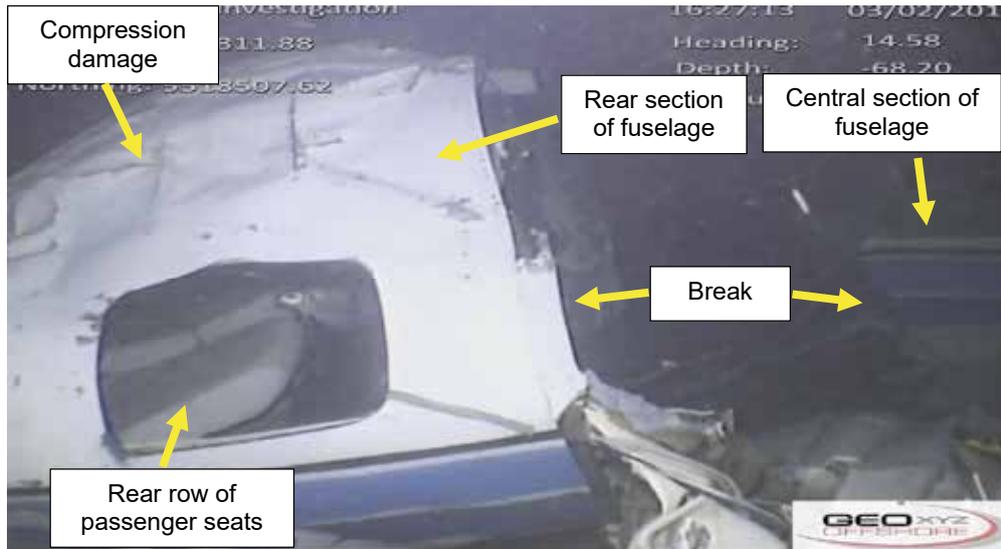
Figure 18

Break in central fuselage

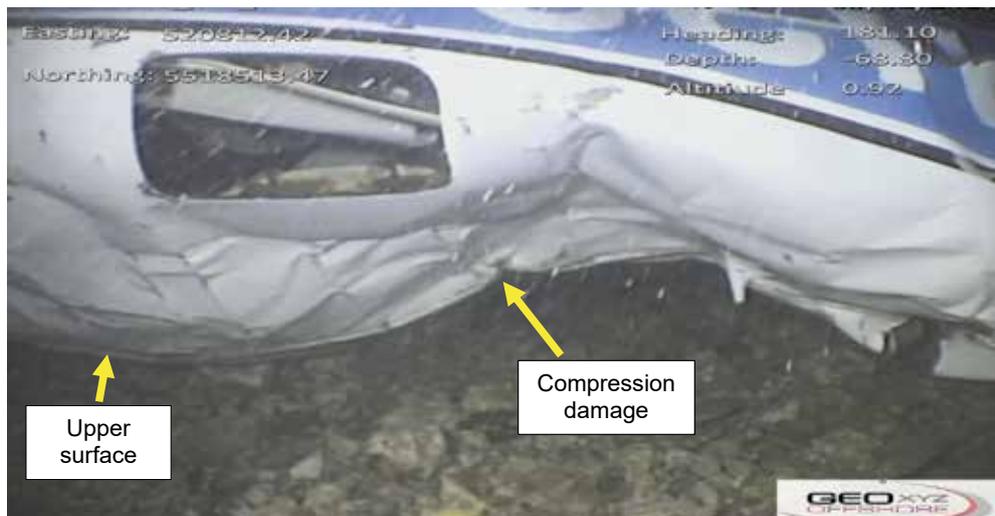
Figure 19

Damage to roof of rear section of the fuselage
(This section of the fuselage has been rotated by the tidal flow)

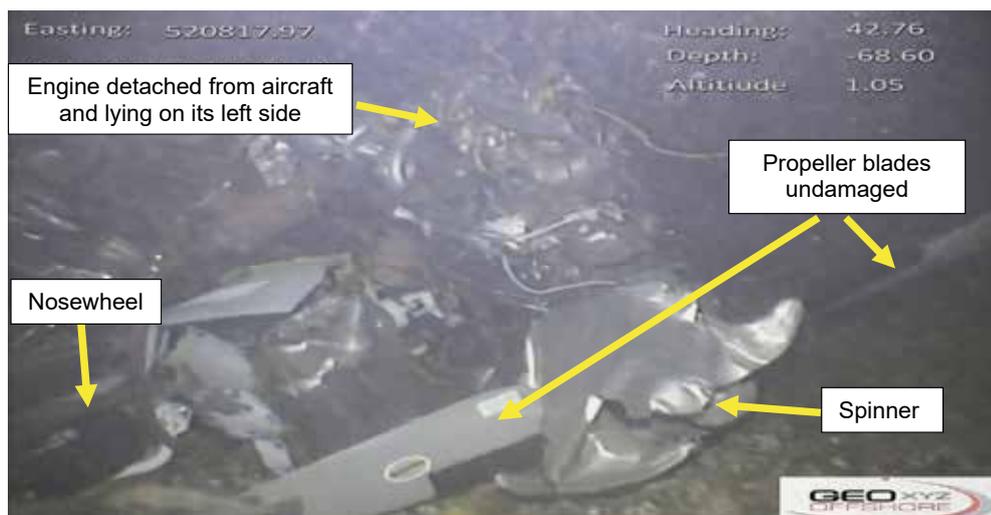
Figure 20

Apart from a slight rearward bend in one of the blades, the propeller blades were undamaged. The engine cowlings had detached and the engine and nosewheel had rotated 90° relative to the front of the cockpit. Several components had detached from the engine. The right tailpipe / heater shroud was still attached to the right turbocharger and video footage of part of the right tailpipe showed no evidence of scoring on the inside. There was no evidence of burnt oil residue on the inside of the exhaust. The induction, heating and ventilation pipes, and the engine baffles had been disrupted. The ignition harness was still connected to the engine.

Propeller and engine

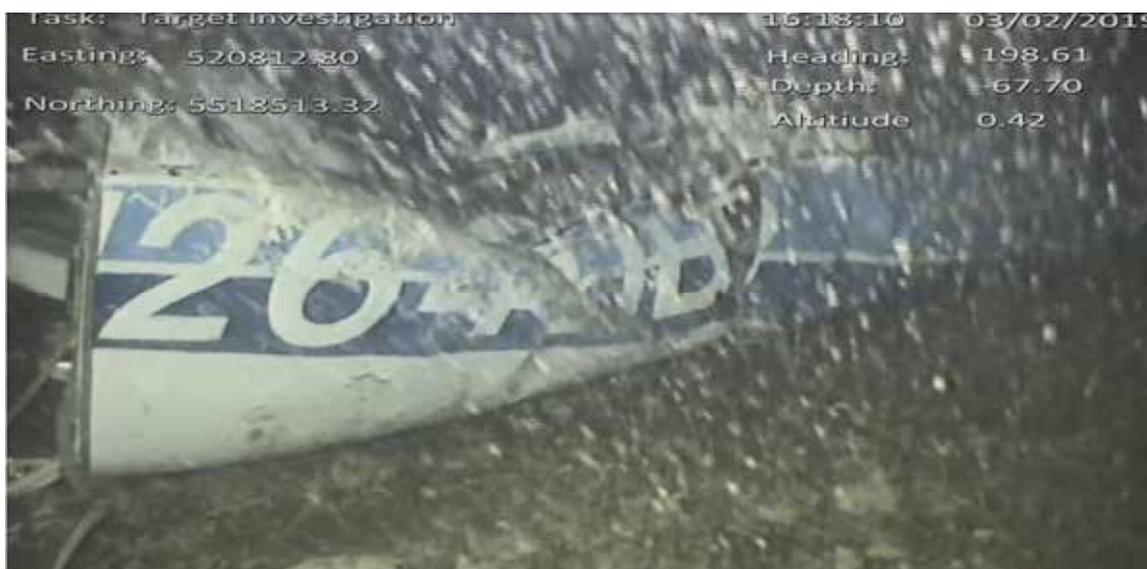
**Figure B-6**

Tail section of N264DB on seabed at a depth of 68 m

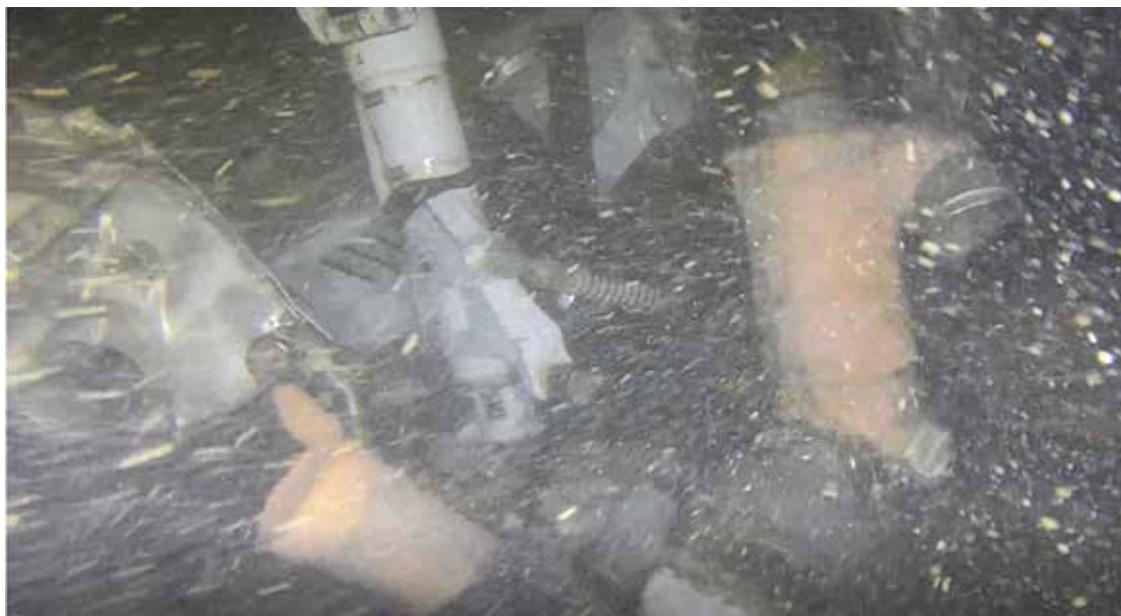
**Figure B-7**

Right tailpipe and heater muff / shroud
(image taken from video provided by Blue Water Recoveries)

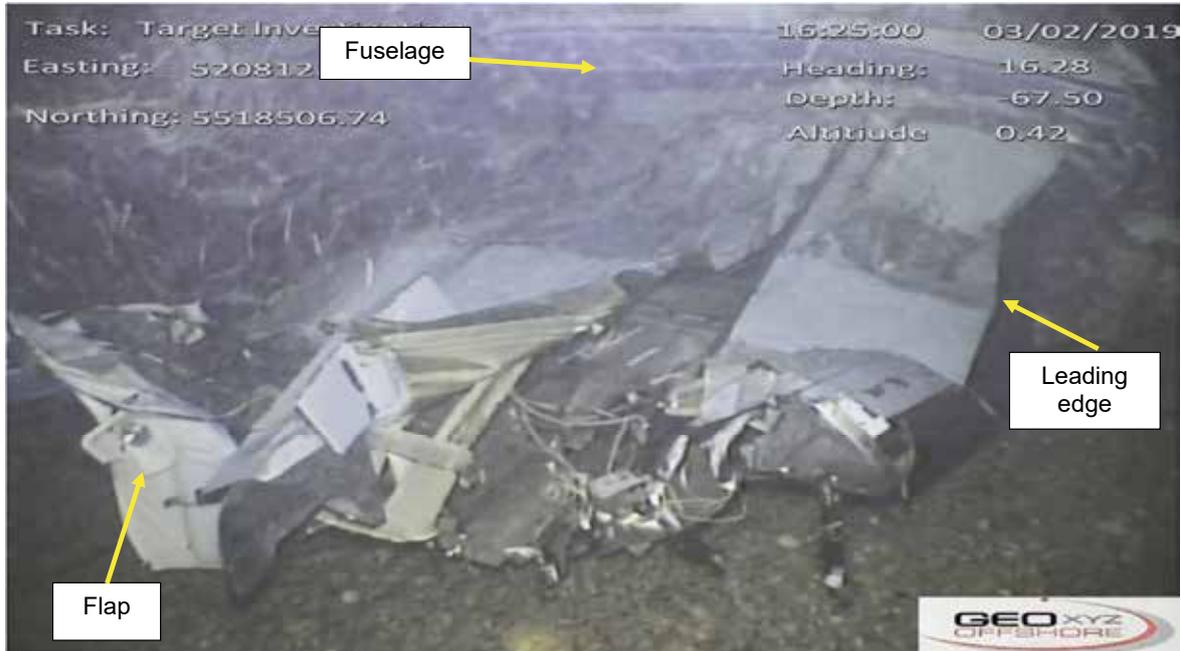
Figure B-8
Remains of right wing

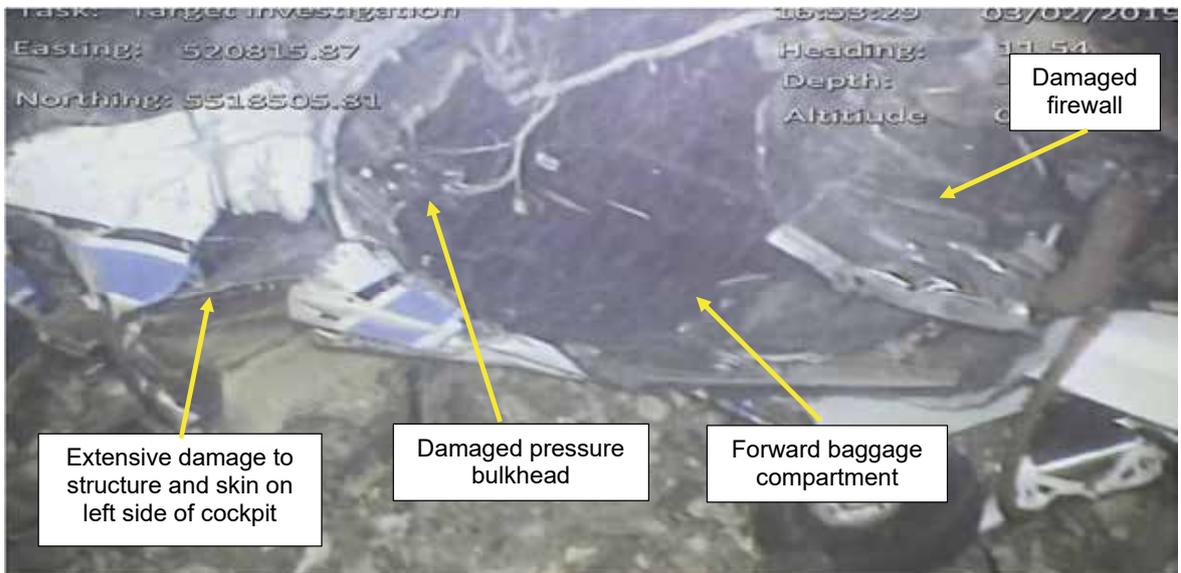
Figure B-9
Forward of cockpit

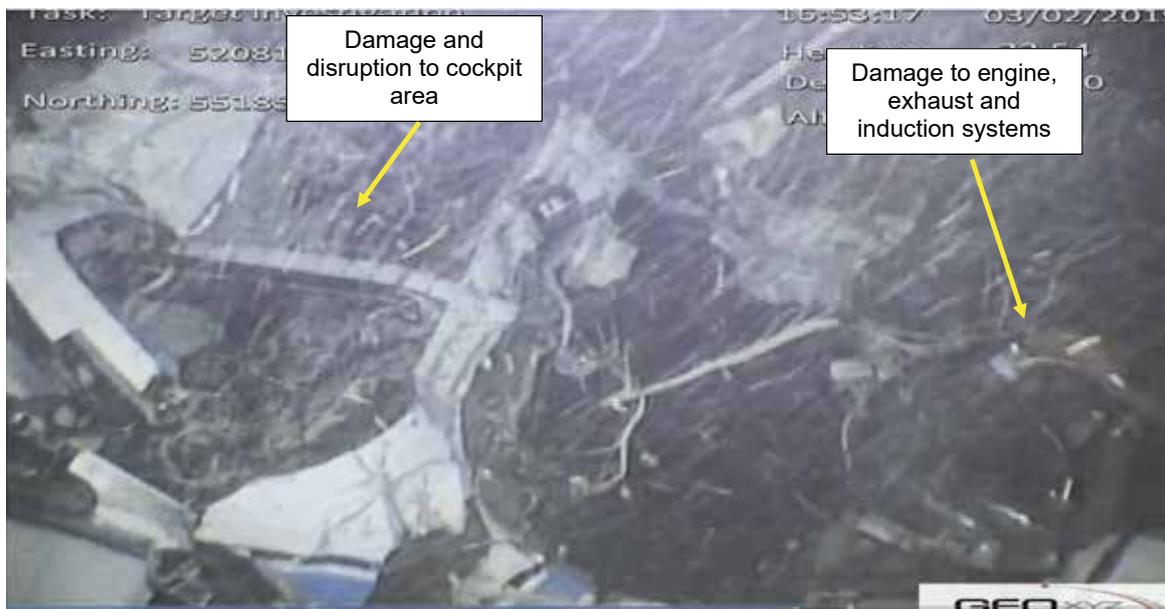
Figure B-10

Disruption to cockpit and engine

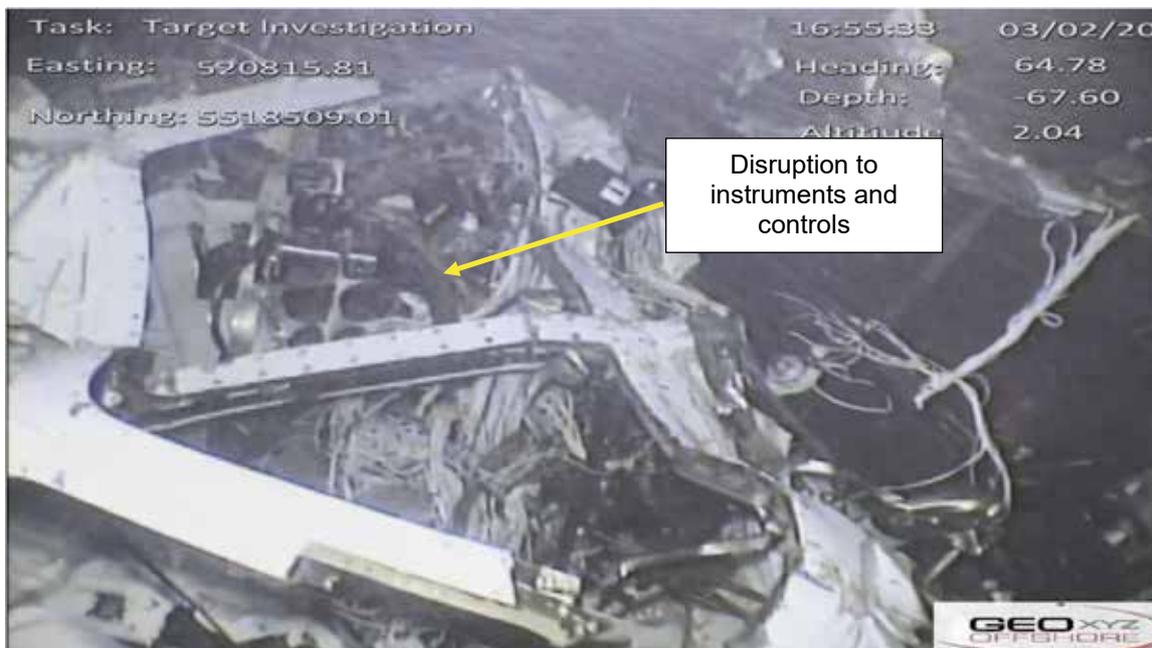
Figure B-11

Damage and disruption to instruments and controls

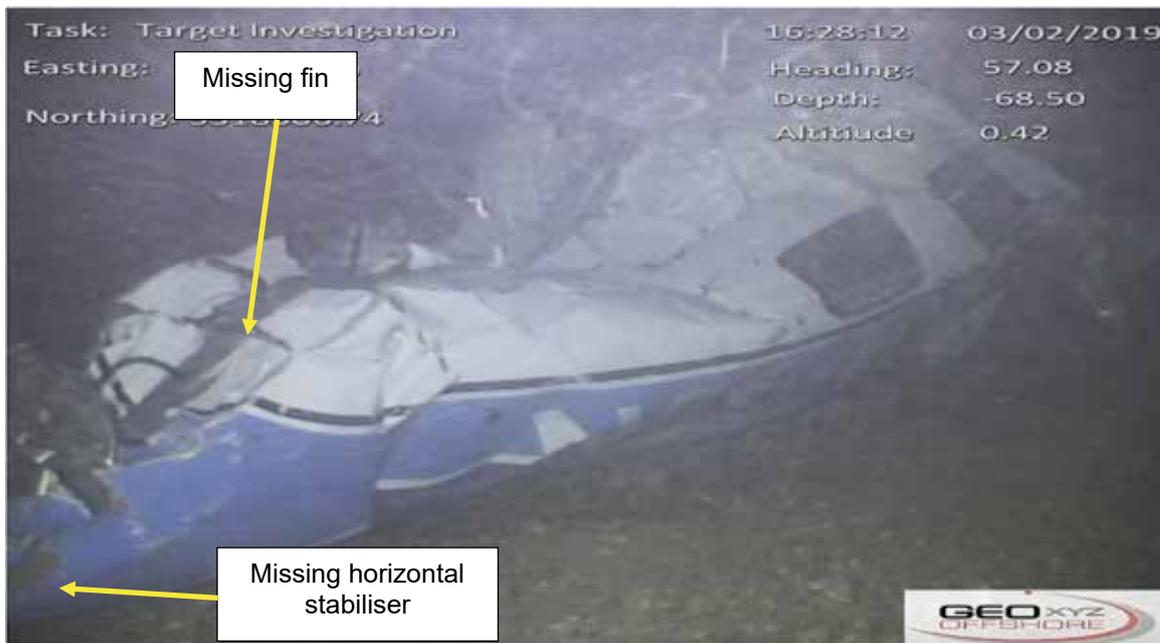
Figure B-12

Missing fin and horizontal stabiliser
