AIRCRAFT ACCIDENT REPORT 1/2020

Report on the accident to
Piper PA-46-310P Malibu, N264DB
22 nm north-north-west of Guernsey
on 21 January 2019

Air Accidents Investigation Branch

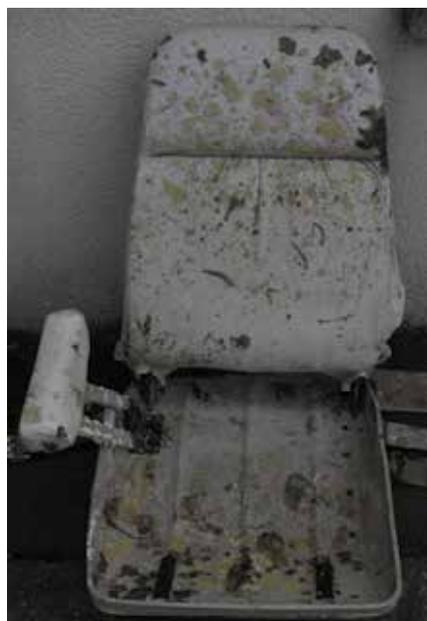
Figure B-2

On 26 September 2019, the crew of a trawler informed the French authorities that they had brought up what they believed to be an aircraft seat while conducting a trawl approximately 7 km to the west of the location of the main wreckage site. The seat was assessed by the AAIB as the left middle passenger seat from N264DB (Figure B-2).

Passenger seat from N264DB

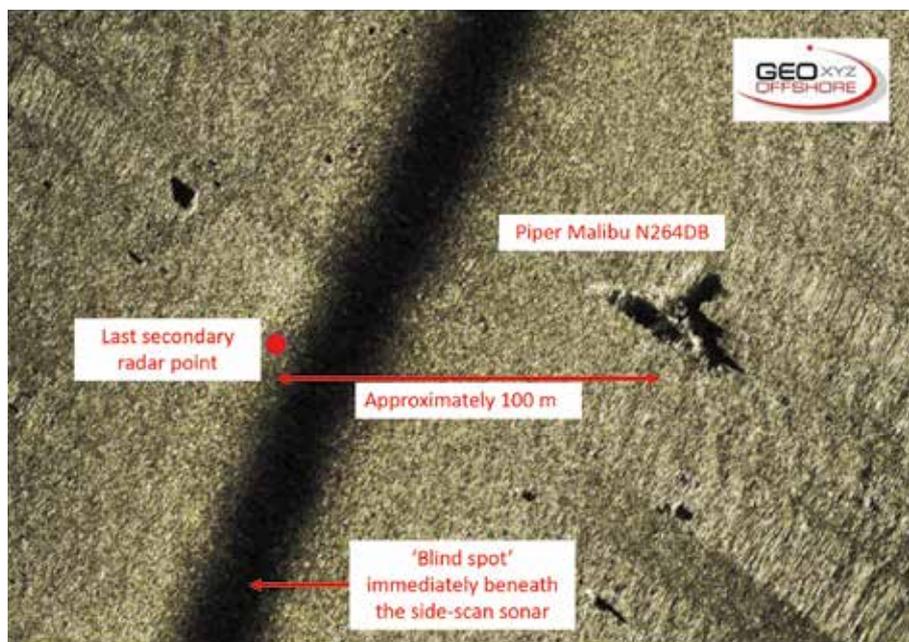
Figure B-5
Side-scan sonar image of N264DB

Both vessels began their side-scan survey of the seabed on the morning of 3 February 2019. Early in the search, the FPV Morven identified an object of interest at a depth of approximately 68 m and cleared the immediate area. The Geo Ocean III subsequently used its own side-scan sonar to observe the object (Figure B-5).

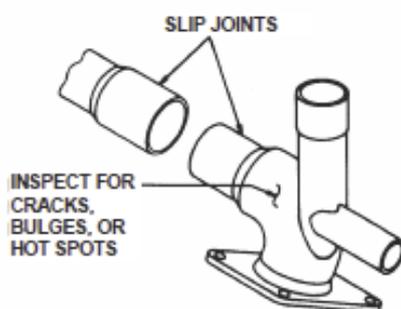
Figure 6-96. Exhaust Slip joint Inspection

4. Connect a high volume, dust-free, air pressure source to the exhaust tailpipe outlet.
5. Apply five (5) psi of air pressure to the exhaust system. Apply soapy water to the exhaust system and check for bubbling in areas of the exhaust other than the slip joints. If bubbling is found, replace the leaking exhaust components according to the instructions in primary ICA (Ref: Section 1-1.1) or aircraft maintenance manual.
